**BMW of North America  
Vehicle Inspection Report**

Vehicle Owners Name: Karen White  
VIN: WBAPN73569A265980

Model: 2009 335d

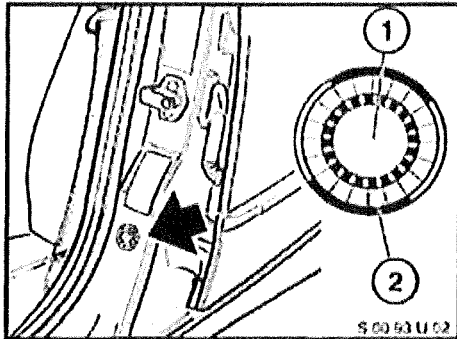
#### LABEL INSTRUCTIONS

This Service Action has been assigned code number **616**. After the vehicle has been checked and/or corrected, obtain a label (SD 92-403) and:

- A. Emboss your BMW center warranty number in the middle of the label (1);
- B. Punch out code number **616** (2), printed on the label; and
- C. Affix the label to the B-pillar as shown.

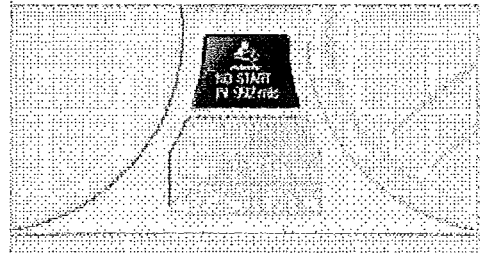
### Reserve display

A display in the instrument cluster informs you about the remaining distance you can drive with the fluid remaining in the reservoir.

The reserve display appears beginning at approx. 1,000 miles/1,600 km before the supply is used up.

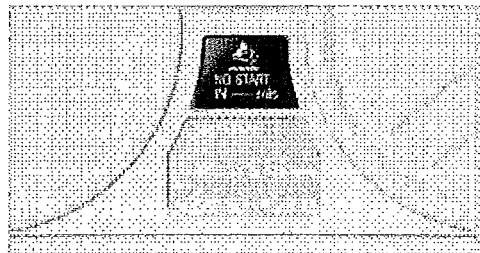
### Diesel exhaust fluid at the minimum level

Even if the display indicates ... miles, the engine continues running if it is not switched off and if all other requirements continue to be met, e.g. a sufficient supply of fuel.

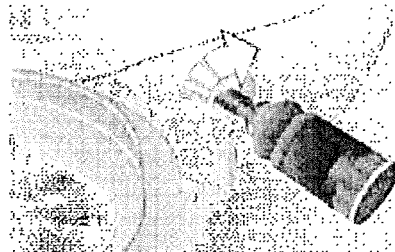
Hold the attached bottle to prevent the thread on the vehicle from becoming damaged by the weight of the bottle. ◀

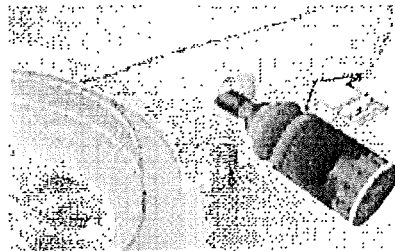
2. Press the bottle toward the vehicle, see arrow. The reservoir in the vehicle is filled.

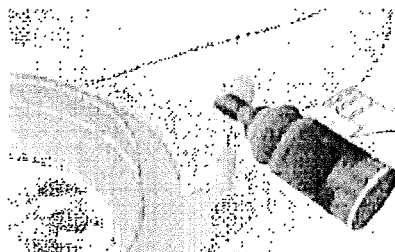
3. The reservoir is full when the filling level in the bottle stops changing. It is not possible to overfill the reservoir. Pull back the bottle, see arrow, and unscrew it.

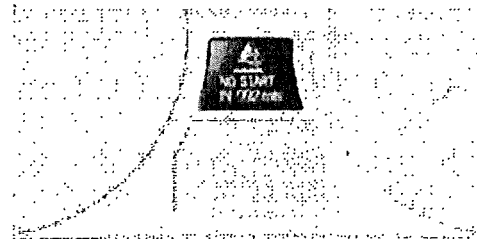
### Reserve display

After refilling, the reserve display continues to be displayed after the engine is started. It goes out after the vehicle has been driven for several minutes.
